FABRICATION OF LIGHTWEIGHT TURBINE
COMPONENTS USING ELECTRON - BEAM WELDING
FOR THE ATTACHMENT OF SHEET METAL BLADES
TO DISCS AND SHROUDS

TECHNOLOGY REPORT

CONTRACT NAS 3-2555

AEROJET-GENERAL CORPORATION
LIQUID ROCKET OPERATIONS
SACRAMENTO, CALIFORNIA

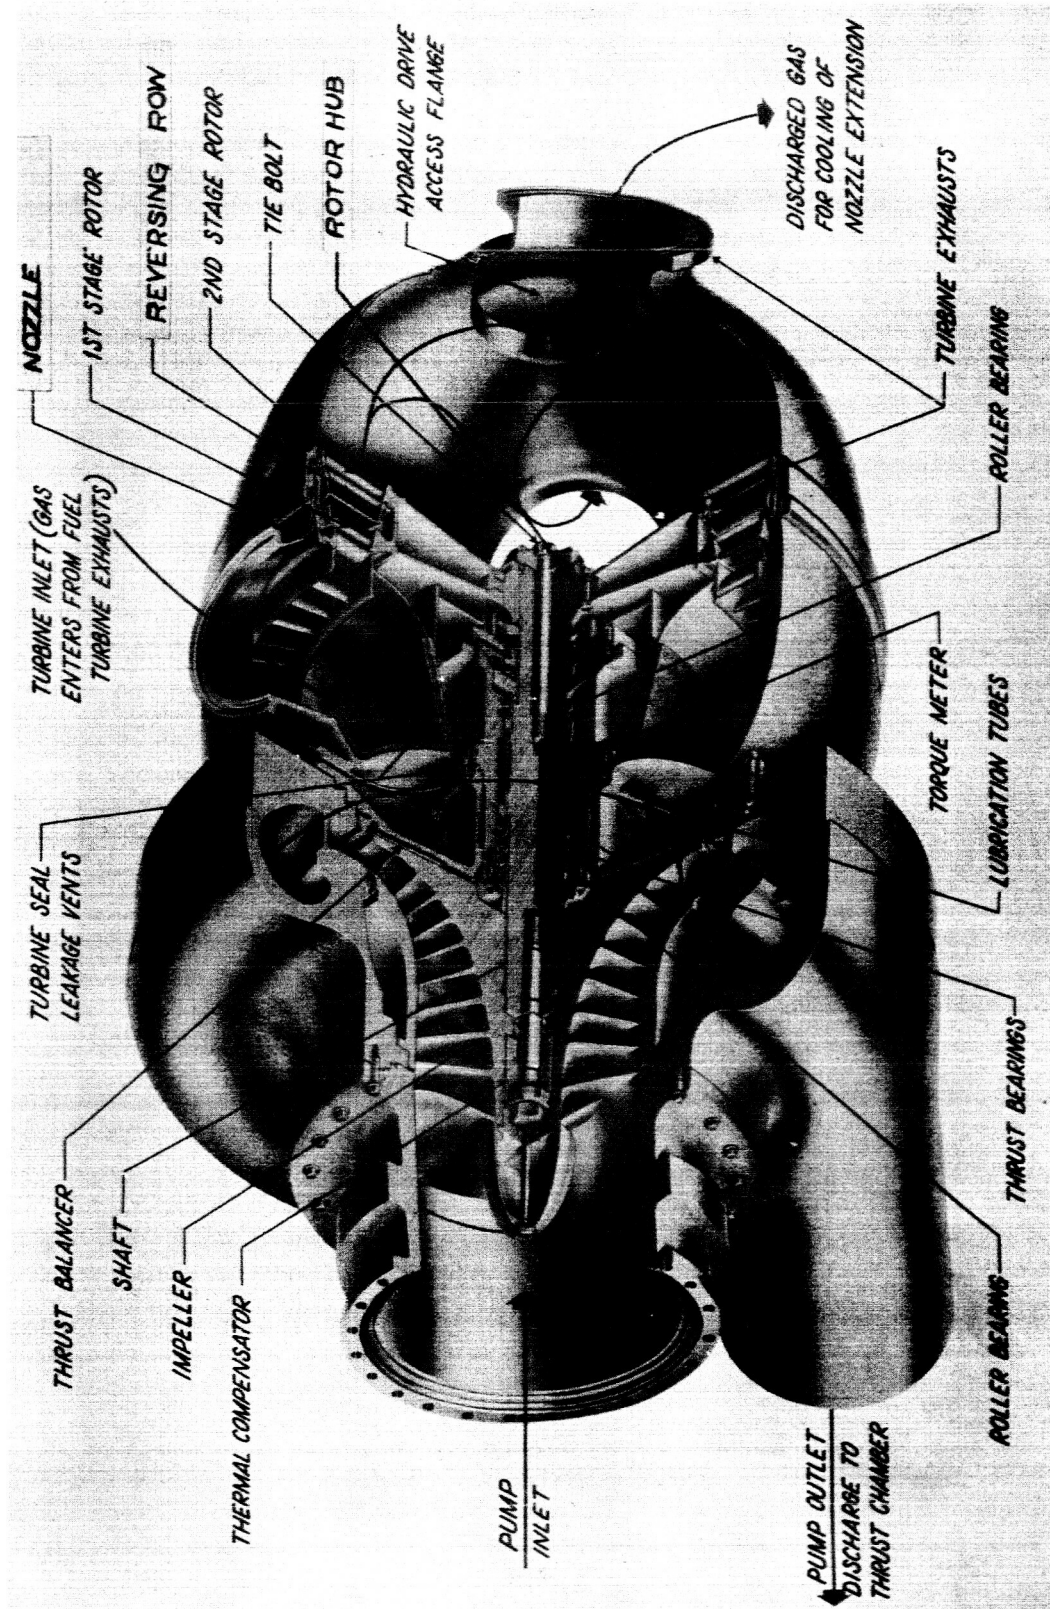
Figure 2

M-1 Oxidizer Turbopump Assembly

The two-stage prototype turbine of the M-1 Oxidizer Turbopump (Figure No. 2) discussed in this report was preceded by a single-stage turbine design for the initial oxidizer turbopump development. A fir-tree attachment was provided in the single-stage turbine design to permit the attachment of shrouded rotor blades to the disc. To expedite fabrication, the first two rotors were manufactured with unshrouded blades. These were machined from a solid disc. The solidity of the preferred fir-tree design with shrouded replaceable blades was somewhat compromised to minimize the large blade overhang that would be required to achieve the desired solidity.

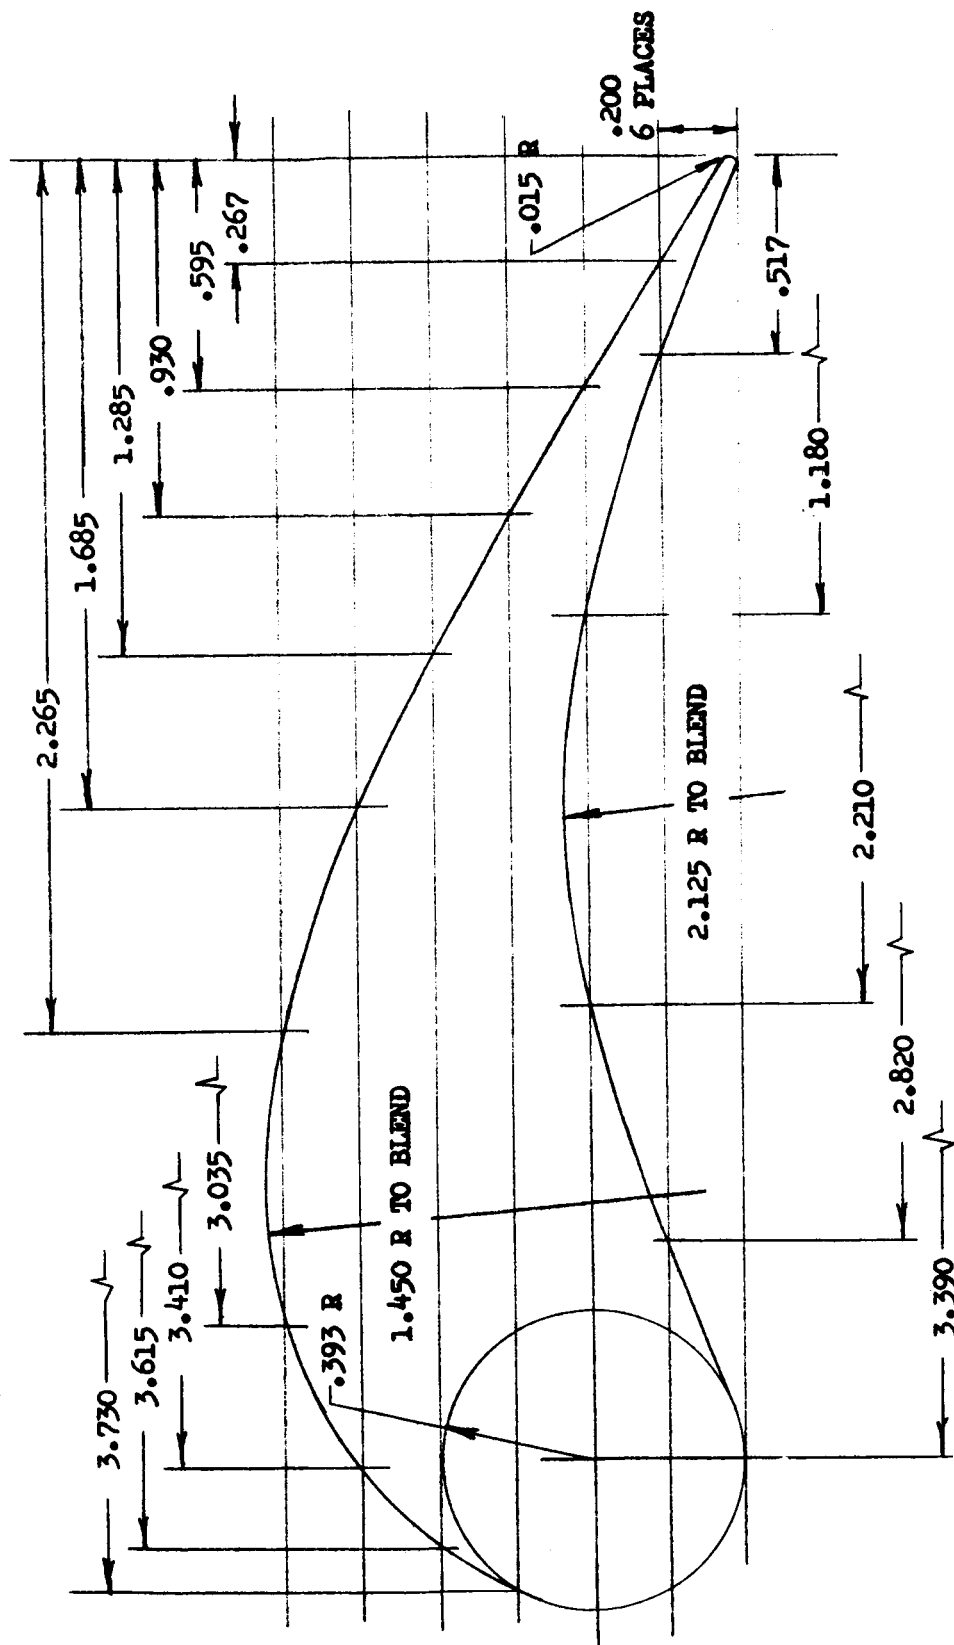
Figure 6

SMOOTH TRANSITION BETWEEN DEFINED POINTS

Nozzle Vane Profile

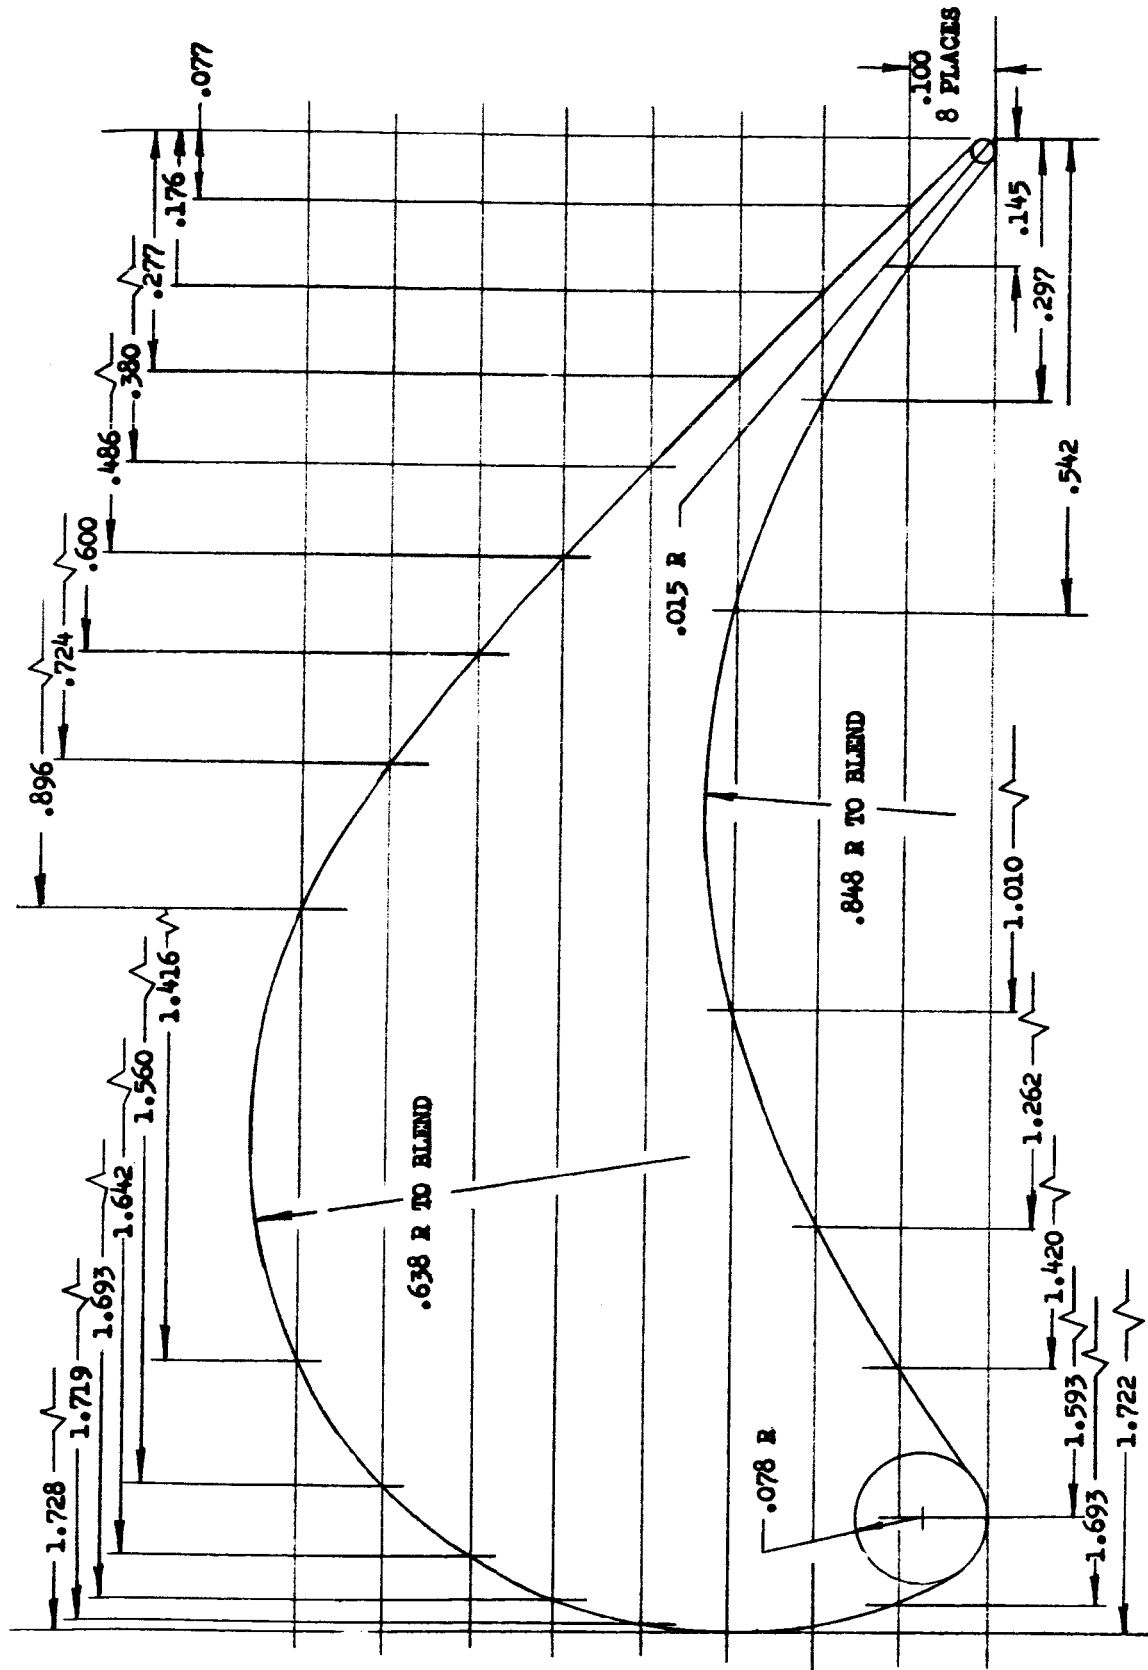
SMOOTH TRANSITION BETWEEN DEFINED POINTS

Figure 7
Rotor Blade and Reversing Vane Profile

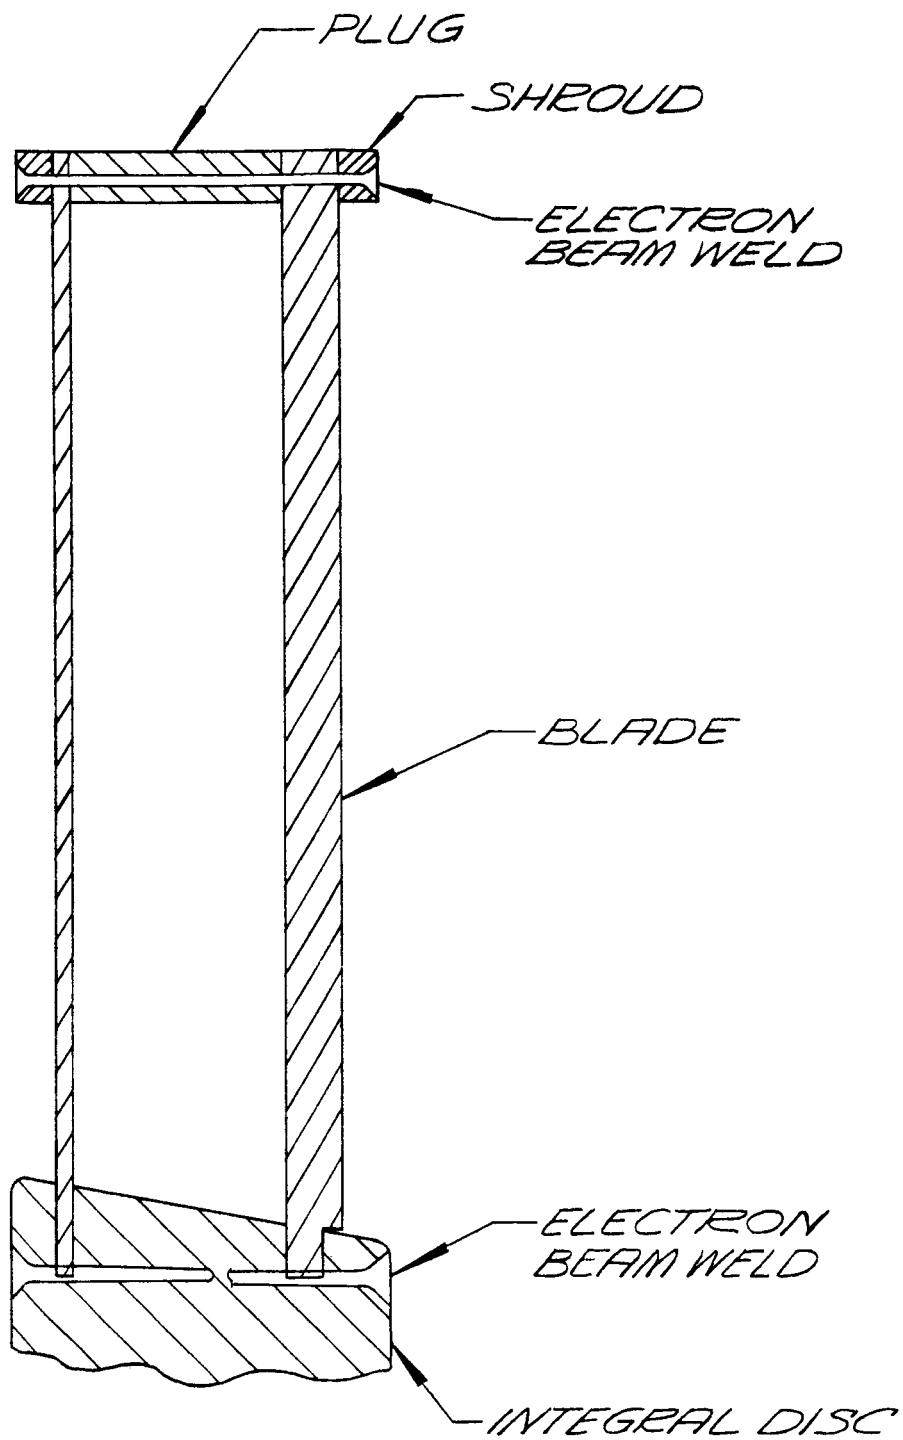
Figure 8

Typical Electron-Beam Weld Configuration

Prior to welding the first dummy rotor, Thompson-Ramo-Wooldridge conducted an extensive weld development program using the weld samples shown in Figures No. 8 and No. 23. Microfissuring was encountered in most weld samples.

Samples of the type shown in Figure No. 8 displayed not only microfissuring but also porosity in the molten zone. This porosity was attributed to inadequate cleaning of the blade and the slot before assembly.

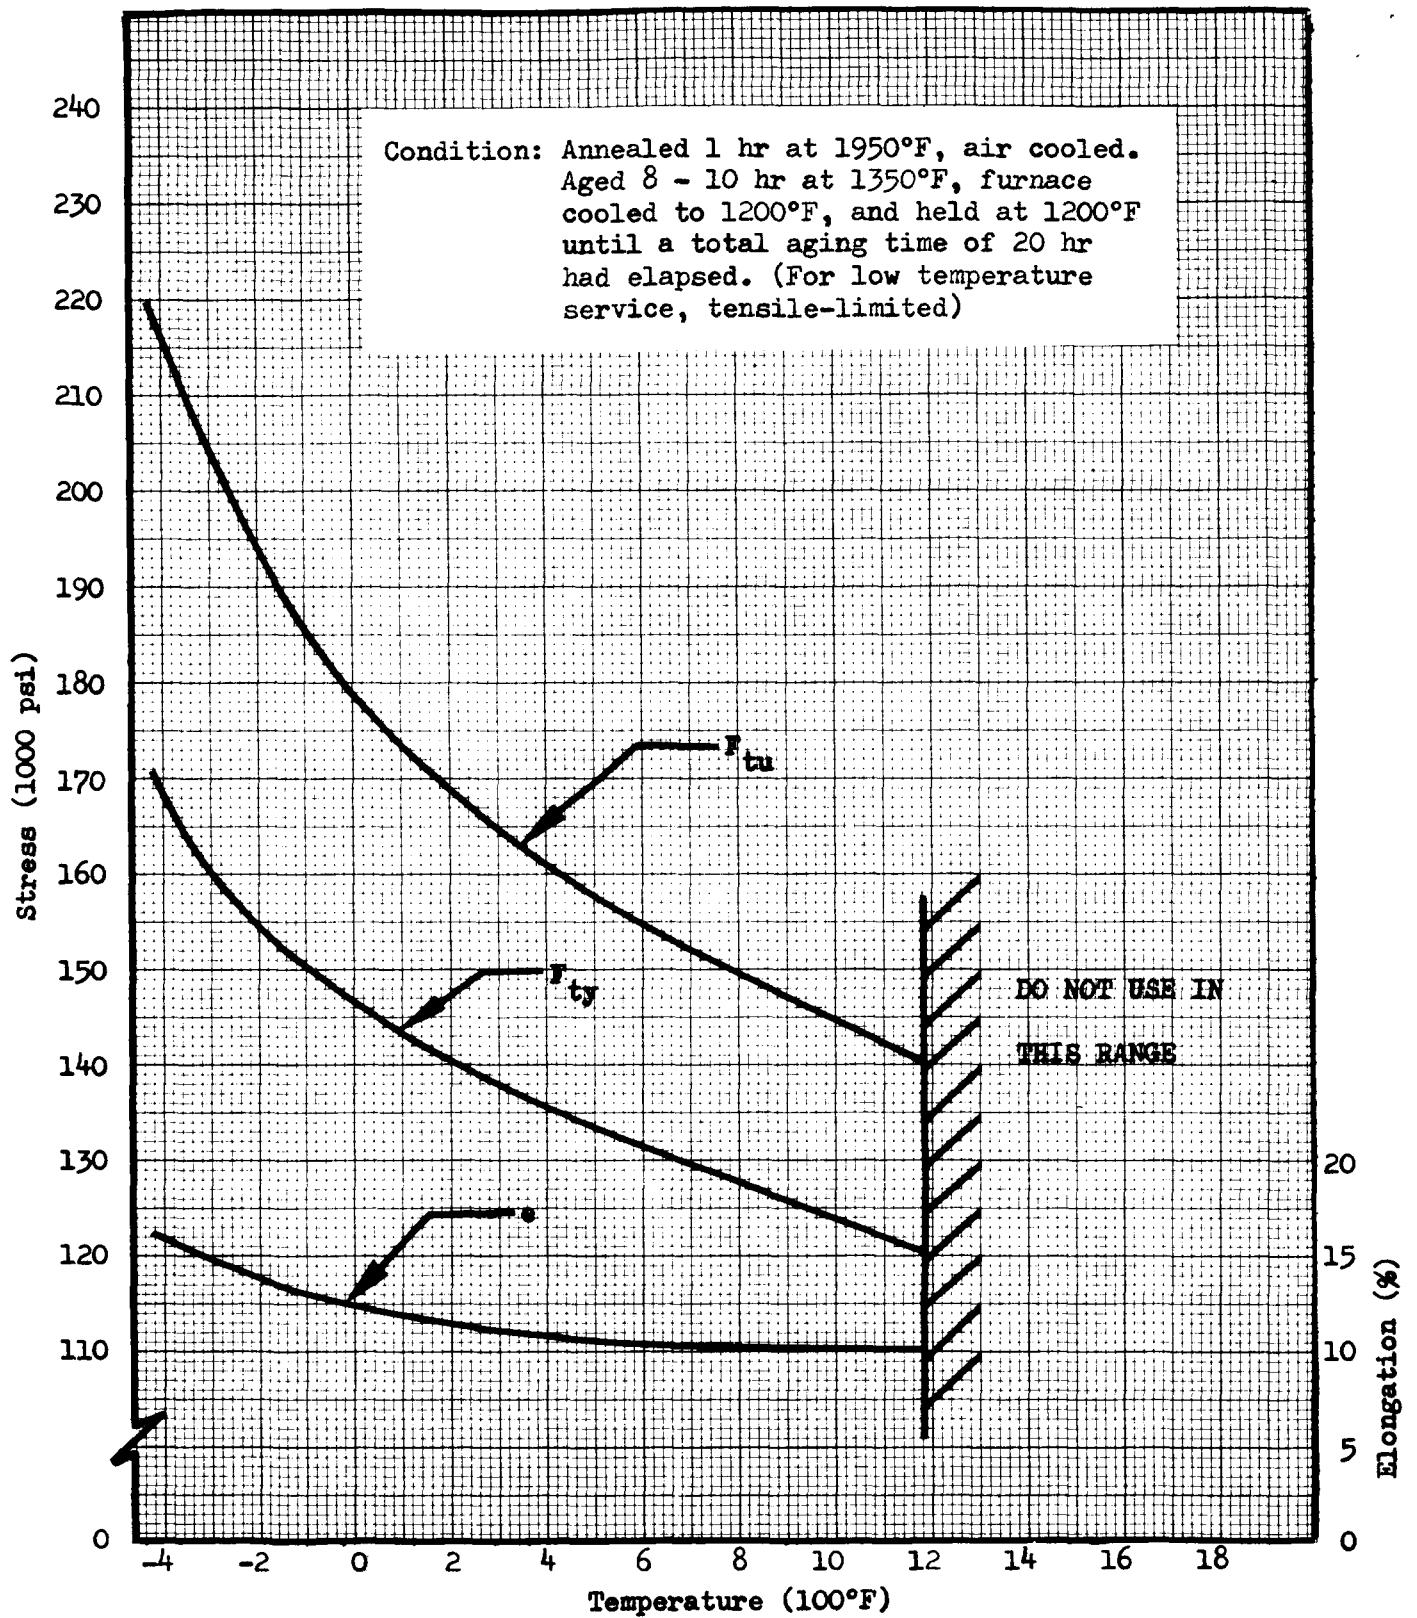
Figure 9

Ultimate Tensile Stress, 0.2% Yield Stress and Elongation vs.
Temperature for Materials of Group 2

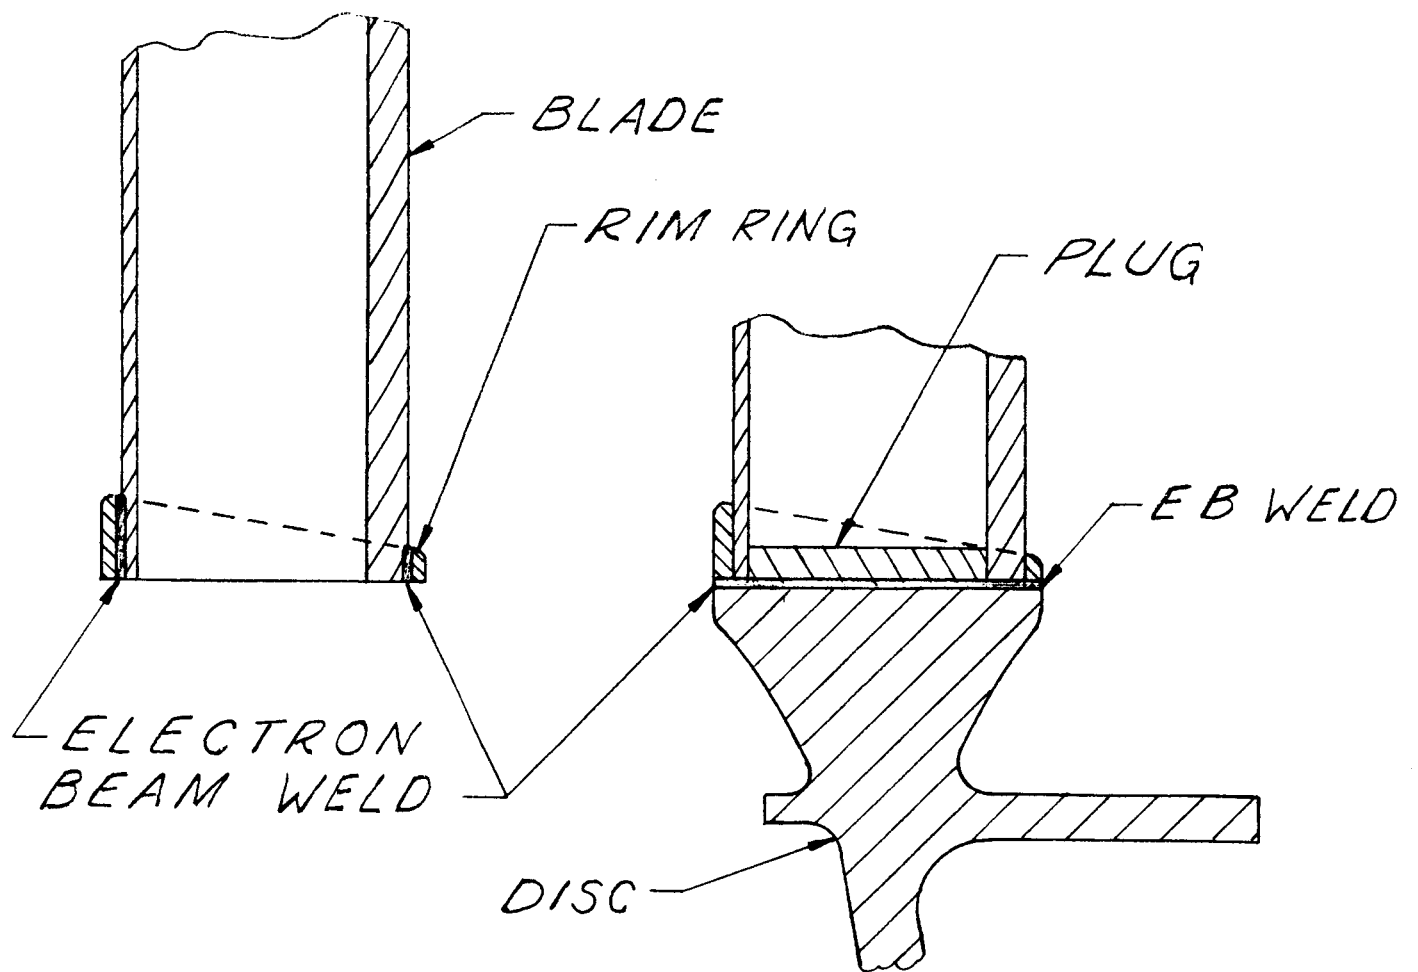
Figure 10

Blade-to-Disc Joint, Radial Contour Weld

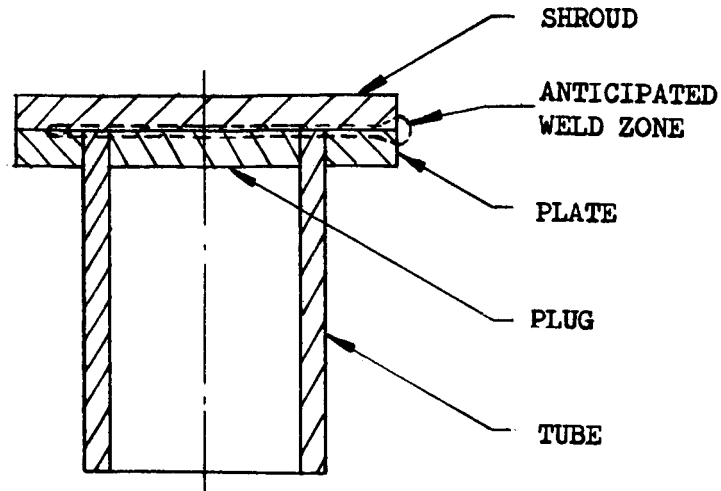
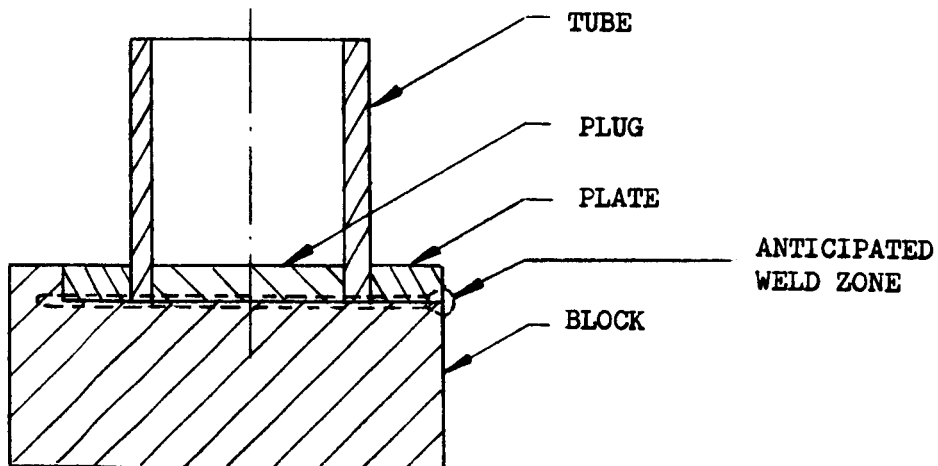
Figure 12

Blade-to-Disc Joints, Axial Butt Joint with Separate Rim Ring

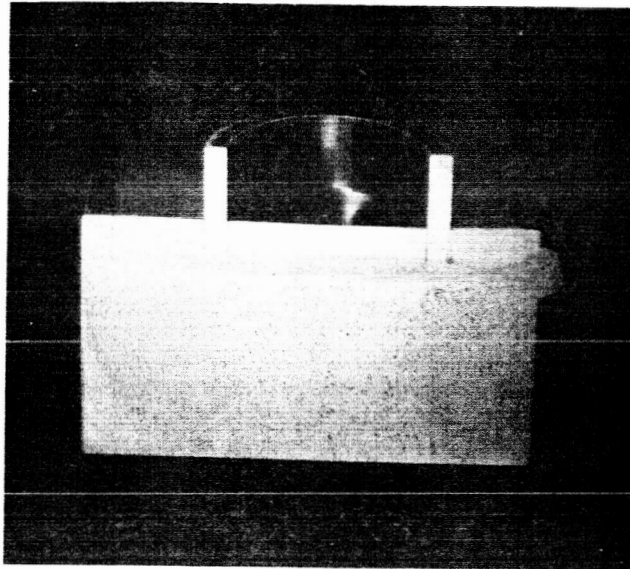
Figure 13

Simulated blade-to-disc joint welded from one side by the electron beam process. Material is Alloy 718.

Simulated blade-to-disc joint electron beam welded from both sides and supplemented with a nickel brazing alloy. Base material is Alloy 718; the brazing alloy conforms to AMS-4777 (LMW).

Weld Sample, Axial Butt Joint With Separate Rim Ring

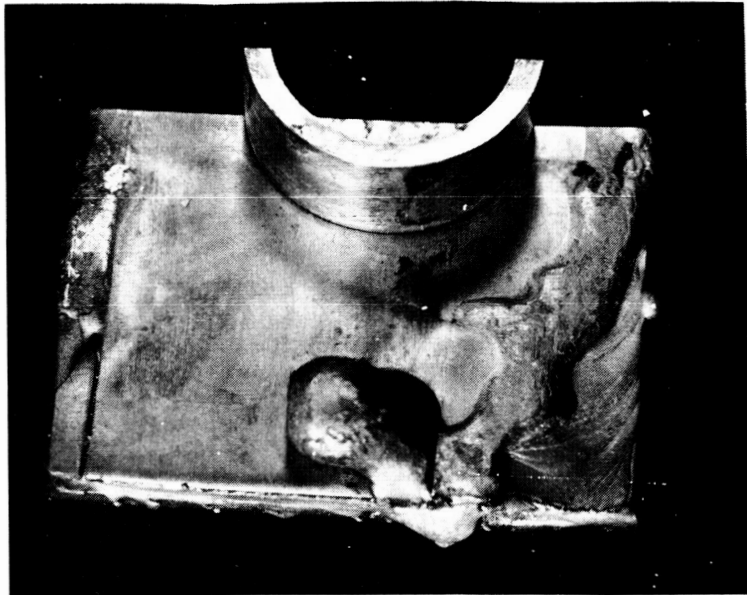
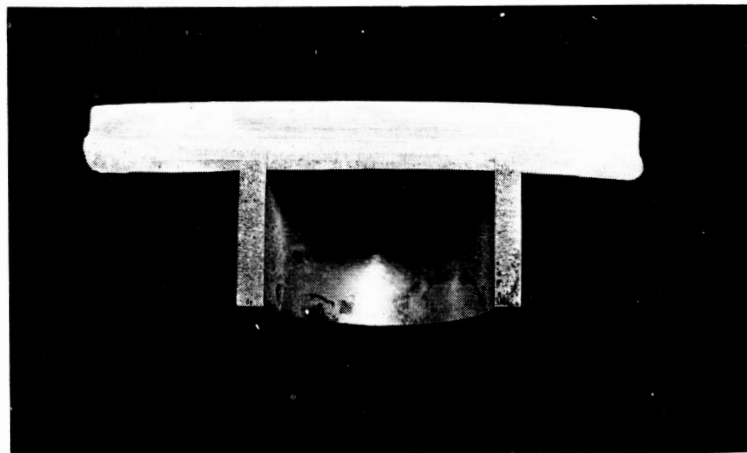
Figure 14

View of the outer blade-to-shroud joint. The thin member (0.090-in. thick) eroded during electron beam welding. All material is Alloy 718.

Cross-sectional view showing full weld penetration. The welding was performed from both sides.

Weld Sample, Axial Butt Joint With Separate Ring on Shroud

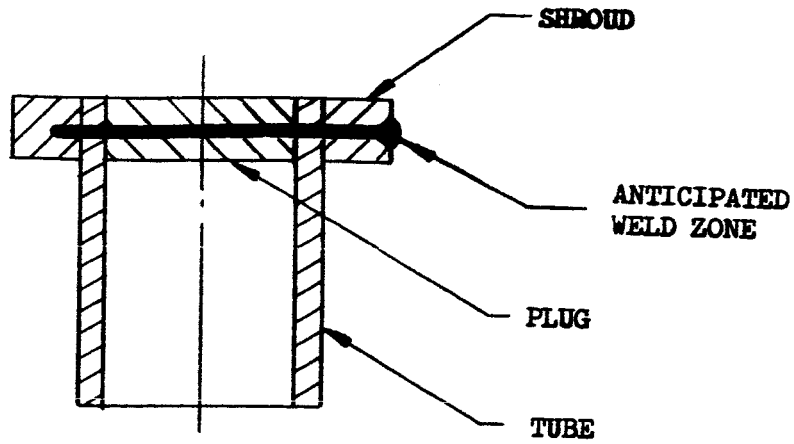
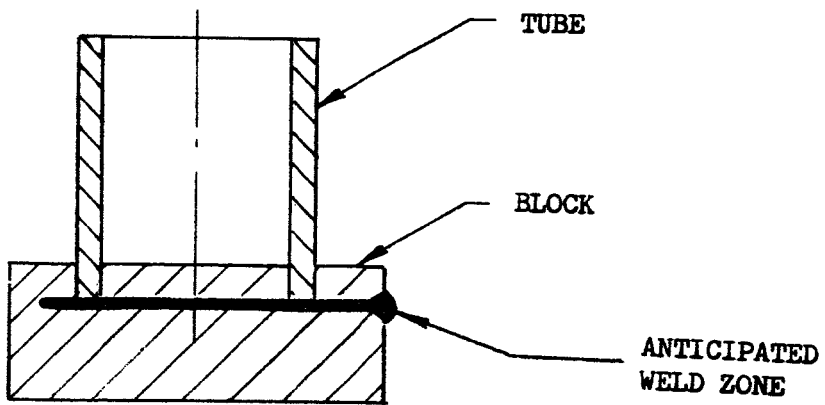
Figure 15

Final Joint Configuration Before Welding

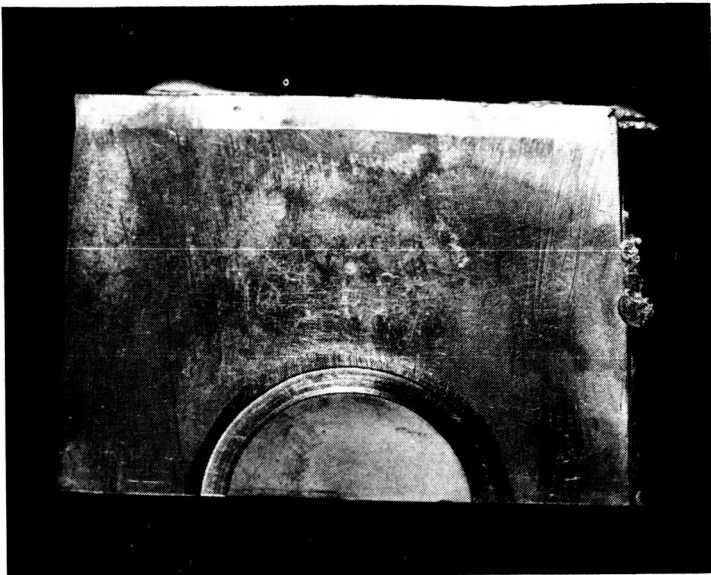
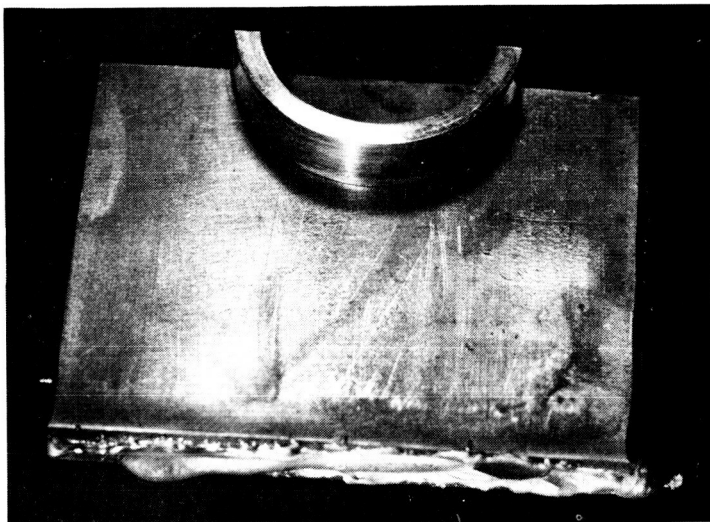
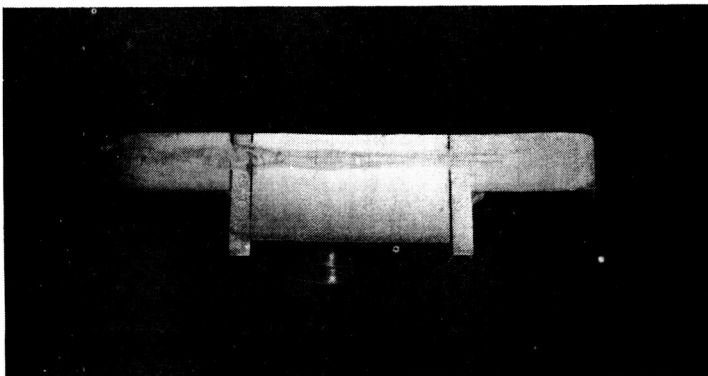
Figure 16

Top view of Alloy 718 tube welded to shroud joint. The tube was plugged to prevent beam deflection and to maintain a constant cross-section area.

Bottom view of the same joint shows no evidence of erosion or weld burnthrough.

Cross-sectional view of the same specimen shows the weld nugget through the center of the shroud. This specimen was welded from one side only.

Weld Sample, Final Shroud Joint Configuration

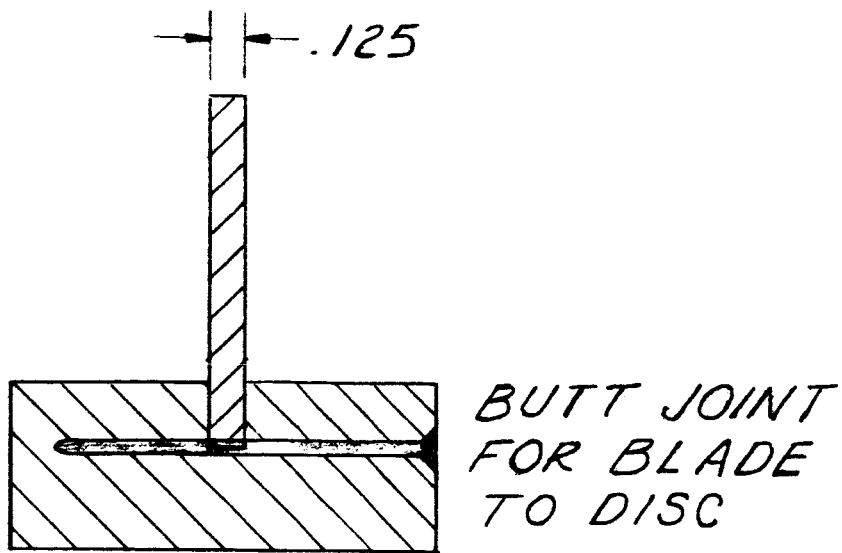
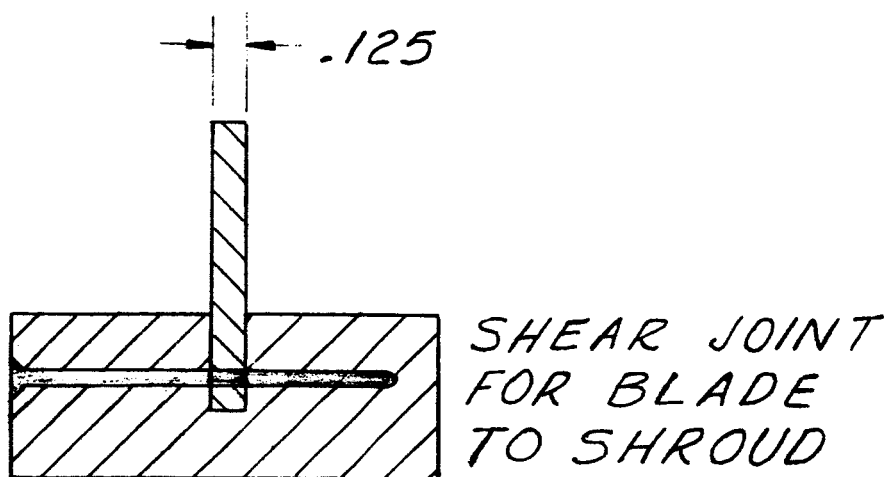
Figure 17

Pull Samples, Final Joint Configurations

Samples were fabricated in a tee-shape for tensile testing the butt-weld joint (representing the blade-to-disc joint) and shear joints (representing the blade-to-shroud joint) (see Figures No. 17 and No. 18). A nickel base braze alloy conforming to AMS 4777 (LMW) was applied to one side of the sample to simulate the actual design. Average room temperature tensile strength of the tee-shaped butt weld joints was 174,000 psi with the failure occurring in the parent material. The shear joint failed in the weld at 168,000 psi average stress. The samples were constructed of 0.125-in. plate simulating the blade to assure failure in the weld during the shear tests. The results of these tests gave no indication for concern regarding the use of the thinner 0.063-in. wall thickness material in the actual configuration.

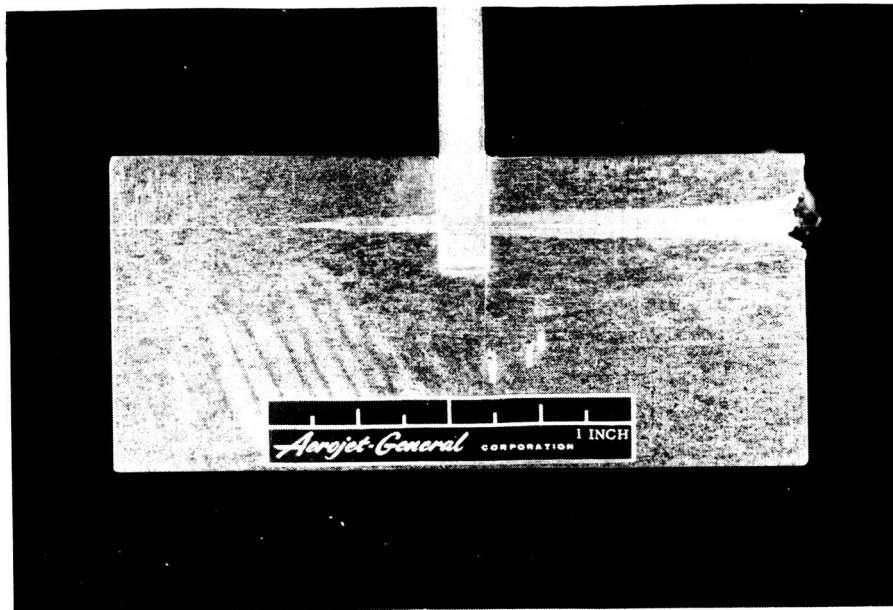
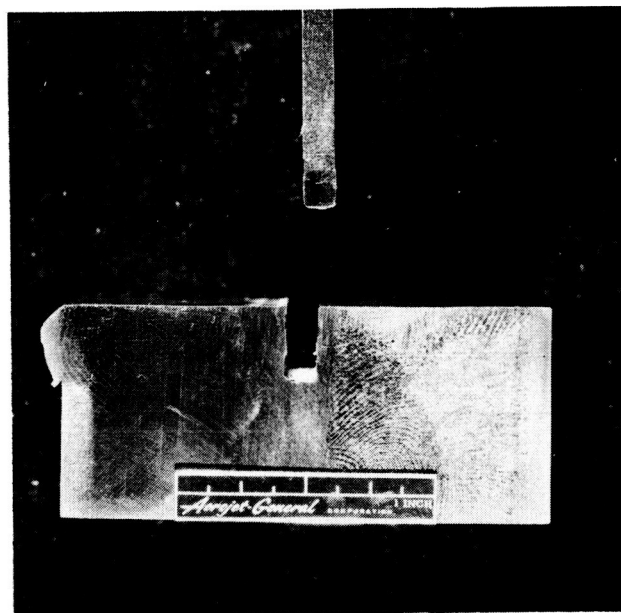
Figure 18

Cross-section view of a T-weld specimen showing the weld nugget through the blade. The weld specimen has braze on the right side at the simulated blade-to-disc joint.

Typical weld shear failure of the test specimen shown above.

Weld Pull Sample, Final Shear Joint Configuration,
Before and After Tensile Testing

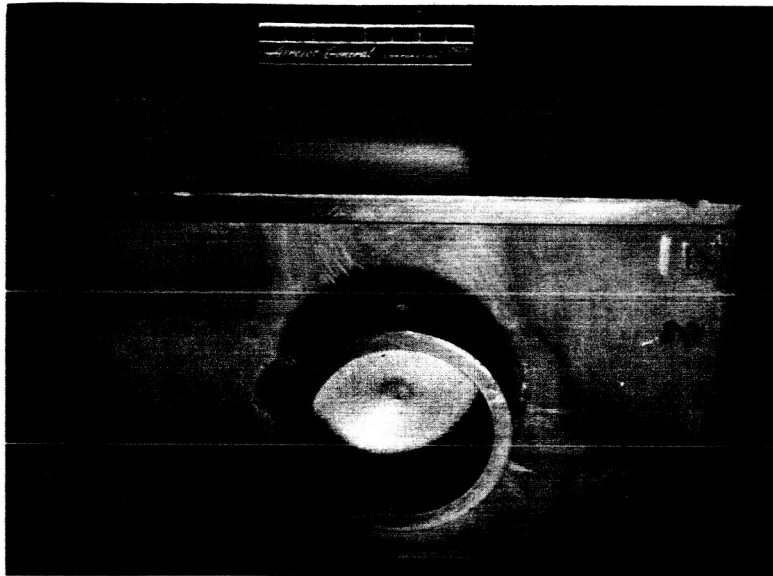
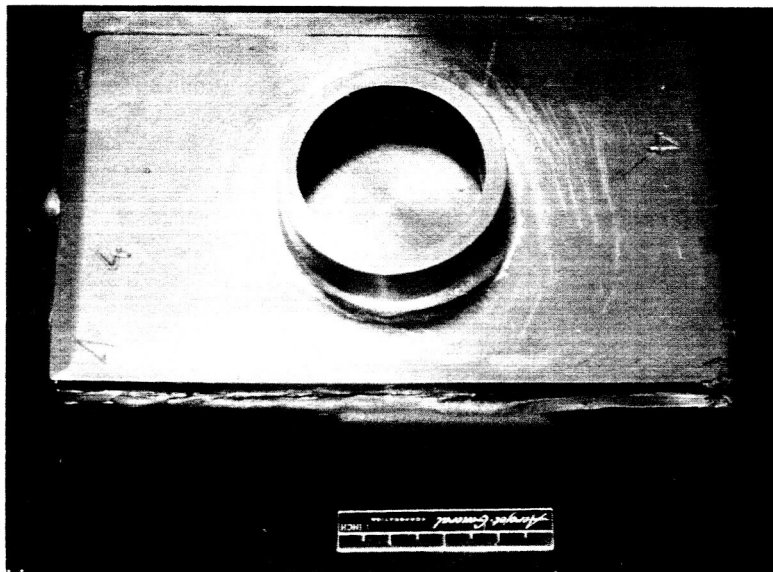
Figure 19

Tube-side of a simulated electron beam welded blade-to-disc specimen after brazing with 82% gold and 18% nickel alloy. Brazing alloy did not wet nor flow uniformly to form a braze fillet.

Same type of specimen shown above except for nickel-base braze alloy conforming to AMS 4777 (LMW). Braze fillet formed uniformly completely around the tube.

The braze fillet was added to provide dampening of the blade and vane vibrations. The first braze alloy used consisted of 82% gold and 18% nickel, but it failed to wet and flow properly (see Figure No. 19). The nickel base braze alloy conforming to AMS 4777 (SMW) provided a satisfactory fillet for vibration damping (Figure No. 19). Brazing was accomplished during the heat treatment cycle based upon experience gained with braze test specimens prepared to determine wetability and flow characteristics of the Inconel 718 material. The braze and heat

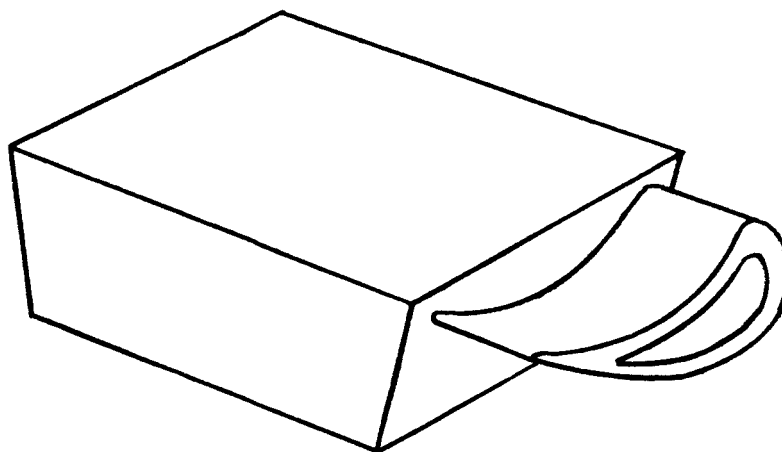
Figure 21

Slot Cutting Electrode for Rotor

The tooling for the EDM machining of the profile slots consists of basic holding and indexing fixtures, and roughing and semi-finishing carbon electrodes. These electrodes are true copies of the blades, cut on a duplicating machine from the serialized blades or vanes. Each blade end was copied on a cutting electrode and had its custom fit slot in the shroud or disc. Figure No. 21 shows such an electrode. All of the slot cutting was done on Cincinnati Electrical Discharge Machines.

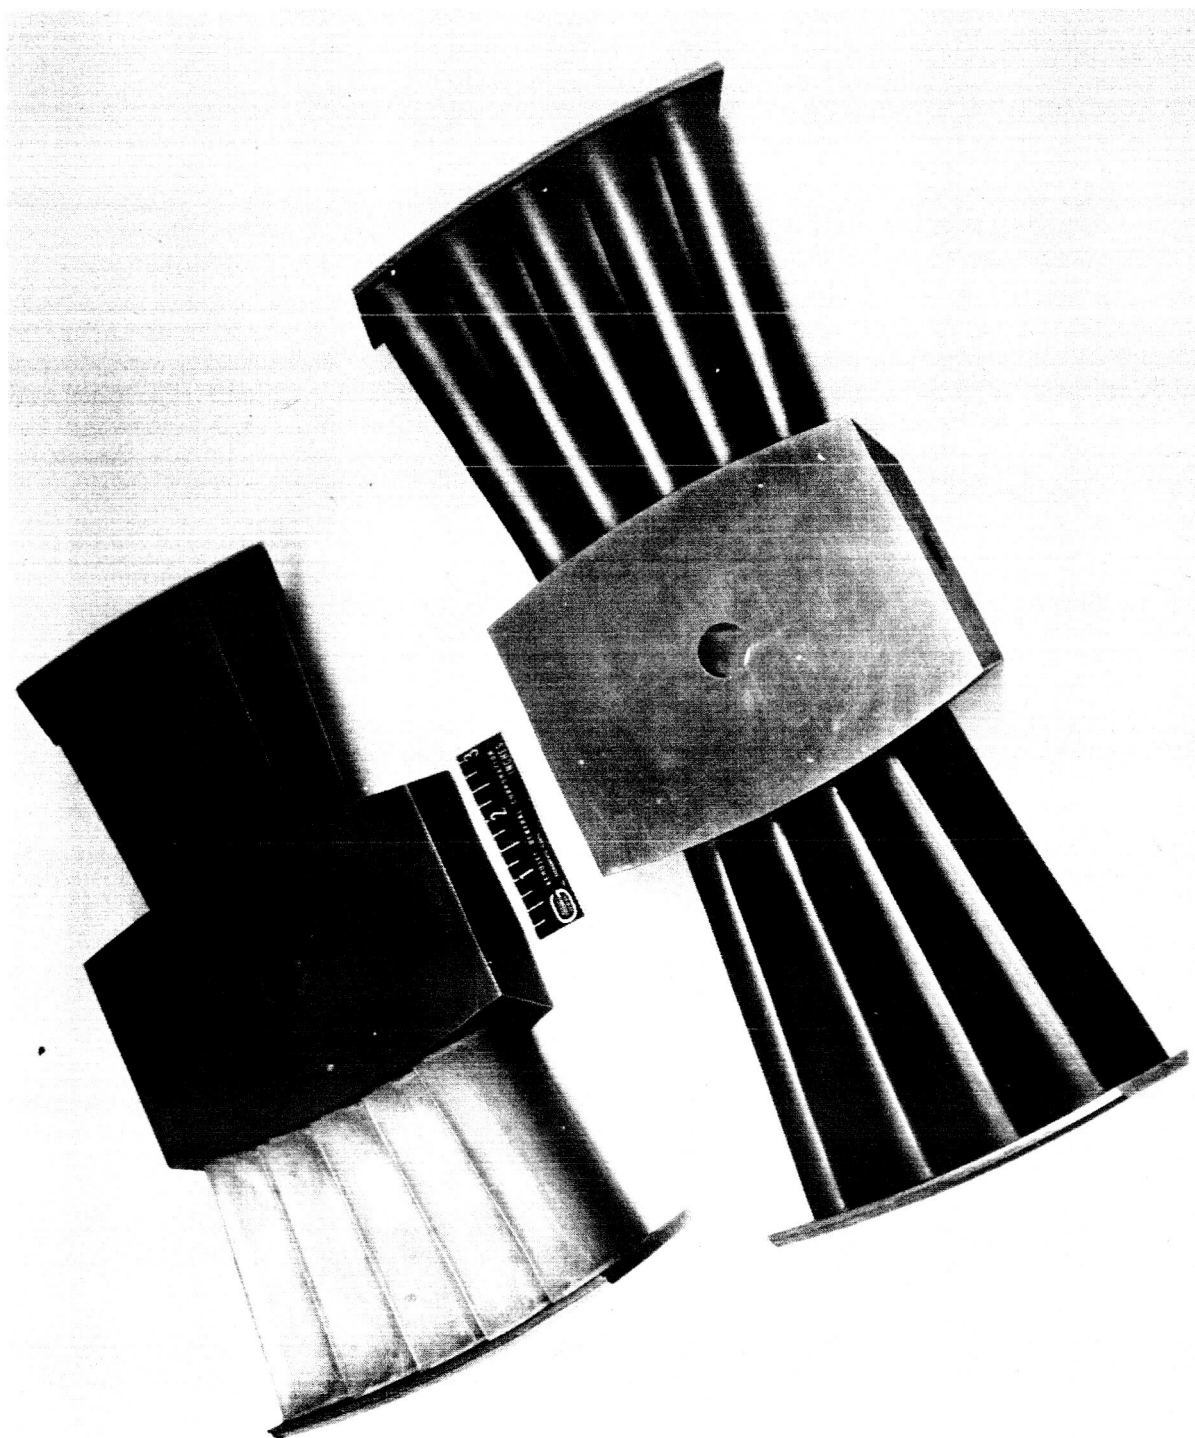
Figure 22

First-Stage and Second-Stage Dummy Rotors

Three dummy rotors were ordered from the vendor; two of these dummies to simulate the configuration of the second-stage rotor and the remaining dummy to simulate the first-stage rotor. Figure No. 22 shows these dummy rotors. One dummy of each configuration was used to establish the natural frequencies of the blade packages. The second stage-two dummy was cut up to evaluate weld joint configuration and weld joint integrity. This was also done to establish inspection procedures and to machine pull samples. Lastly, the dummy rotors provided an opportunity to test tooling that was identical to that intended for the prototype hardware. Aerojet-General awarded a contract to Thompson-Ramo-Wooldridge to evaluate the dummy rotor. The results of this evaluation have been reported elsewhere⁽⁴⁾ and are summarized in the following discussions.

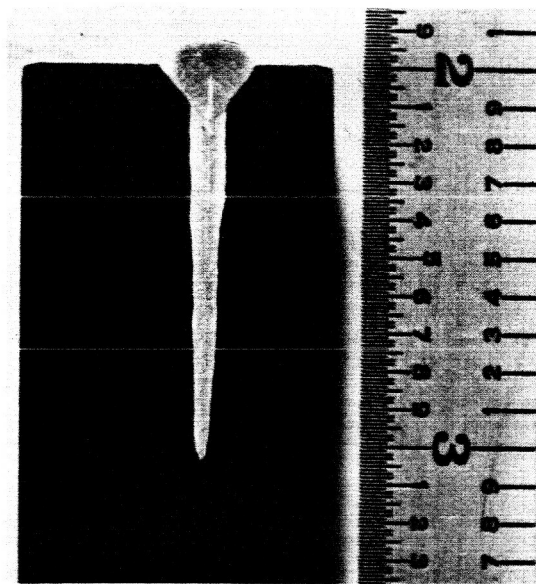
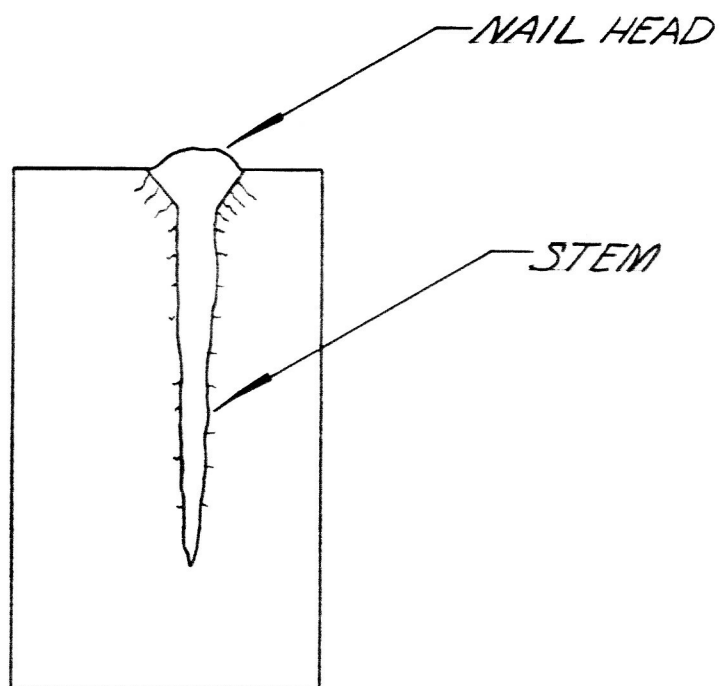
Figure 23

Weld Sample and Schematic of Microfissure Pattern

The microfissuring was most severe in the area of the nail head (see Figure No. 23) where some fissures were 0.030-in. long. Along the stem, a fissure length of 0.005-in. was found. Microfissures existed, in some cases, every 0.030-in. to 0.050-in. along both sides of the nail head and the stem. Figure No. 24 is an enlargement of a typical section of a weld sample.

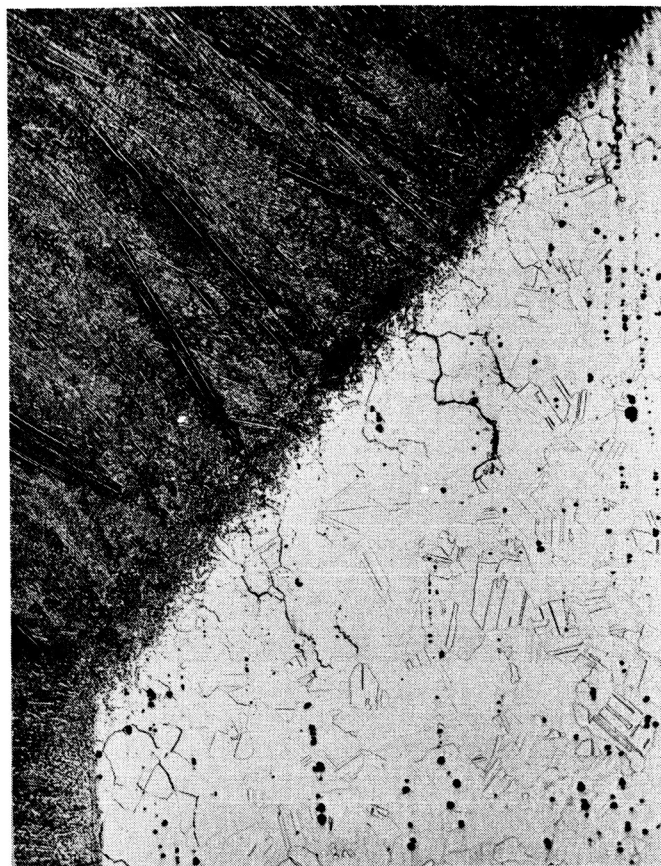
Figure 24

Photomicrograph Showing Microfissuring on Typical Nail Head

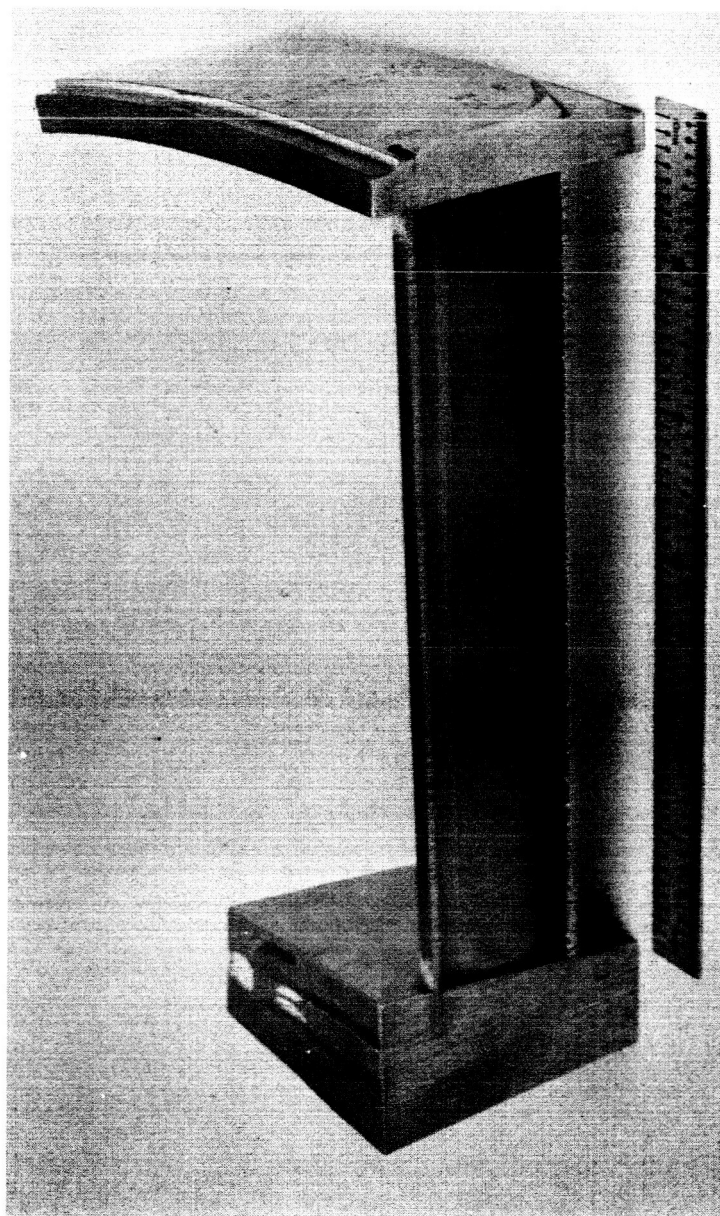
Figure 26

Close-Up of the Vane Section Removed from the Second-Stage
Dummy Assembly After Electron-Beam Welding

After welding the first dummy, a section containing a blade welded to the hub and the outer shroud was cut from the assembly for microexamination. This section is shown in Figure No. 26. The remainder of the dummy was radiographically inspected and gas leaked checked as described in Section III,E,4,a of this report.
